MARINE INVESTIGATION REPORT
M01C0033

TAKING ON WATER AND SINKING

AMPHIBIOUS VEHICLE *LADY DUCK*
OTTAWA RIVER
30 JUNE 2001

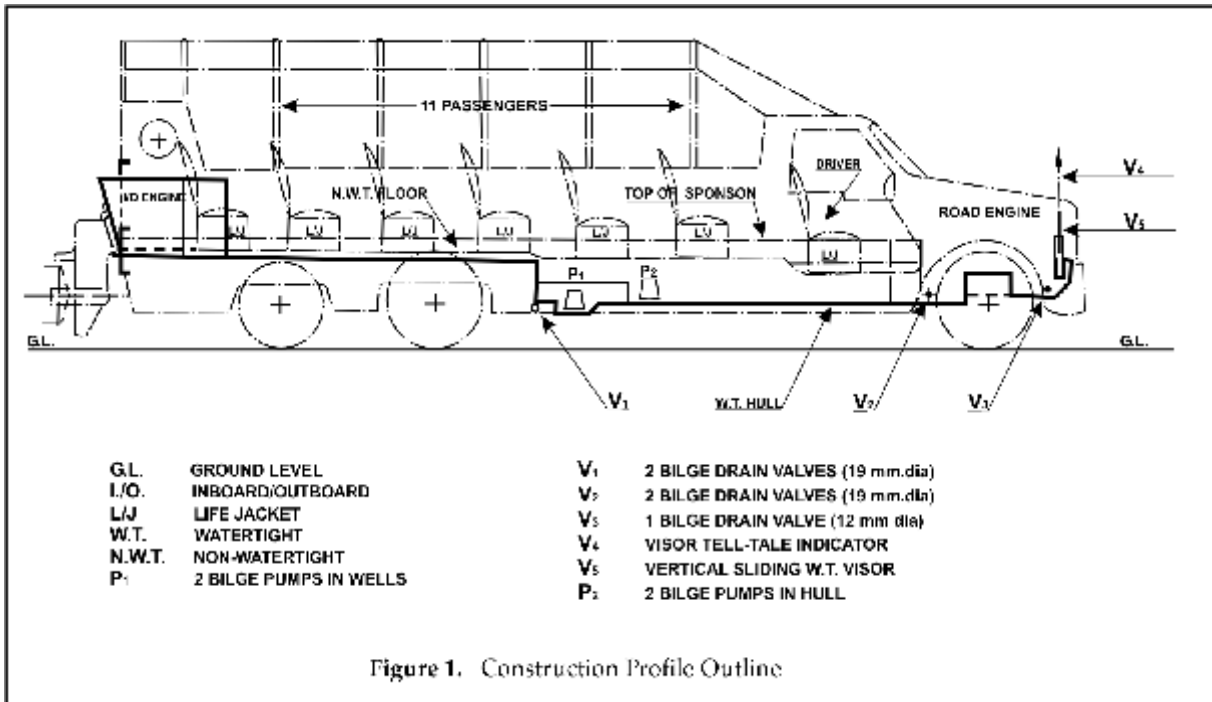
The drainage points are each comprised of hand-operated ball check valves (seacocks) with a swing-check nonreturn valve immediately inboard, both mounted on a common pipe spigot. Four of the drainage points are 19 mm in diameter; the fifth is 12 mm in diameter. They are located as shown in Figure 1.

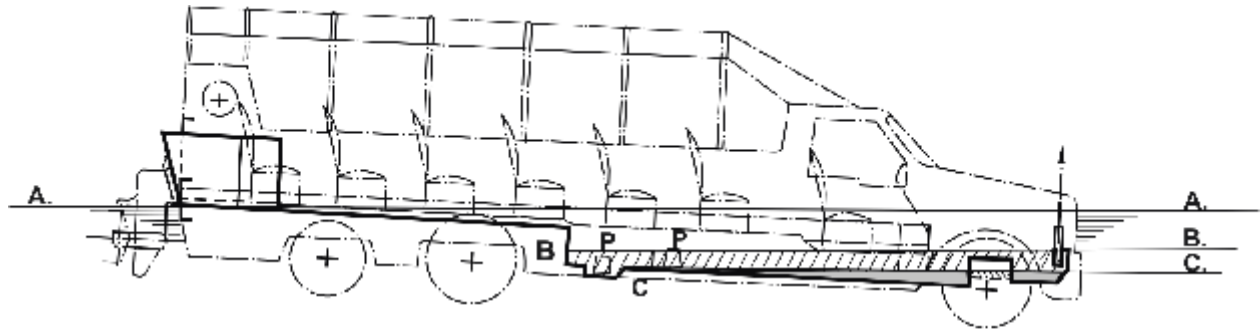
Figure 2. Trim of Partially Flooded Vehicle

The bilge pumps stemmed the inflow and reduced the total accumulation of floodwater while the vehicle was under way. However, the bilge pumps—located near the vehicle's midlength—could not discharge the floodwater that accumulated in the forward end of the trimmed vehicle because this water was below the level of the pumps' suctions (Figure 2). While stationary or being slowly manoeuvred along the river bank toward the disused ramp, the vehicle continued to trim more by the front and to settle deeper in the water.

As attempts were being made to drive the *Lady Duck* out of the water, the front right wheel of the partially flooded vehicle grounded on the left edge of the ramp. The forward momentum and the grounding effect slightly raised the front right side of the vehicle, and the floodwater in the hull surged to the left side. This transfer of weight caused the vehicle to heel to the left and ship more water over that side. The additional shipped water downflooded into the hull and caused the *Lady Duck* to suddenly capsize and sink.

- A-A. TRIMMED WATERLINE OF PARTIALLY FLOODED VEHICLE
- B-B. FLOOD WATER LEVEL WHEN DETECTED BY DRIVER
- C-C. FLOOD WATER REMAINING BELOW SUCTION LEVEL OF PUMPS
